## **NESHAP ASBESTOS SURVEY**

***FORMER COMMERCIAL BUILDING***  
***1 E. Cass Street***  
***Joliet, Illinois 60432***

Inspection Date: June 20, 2024

MEC Project #: 24-06-490-INSP

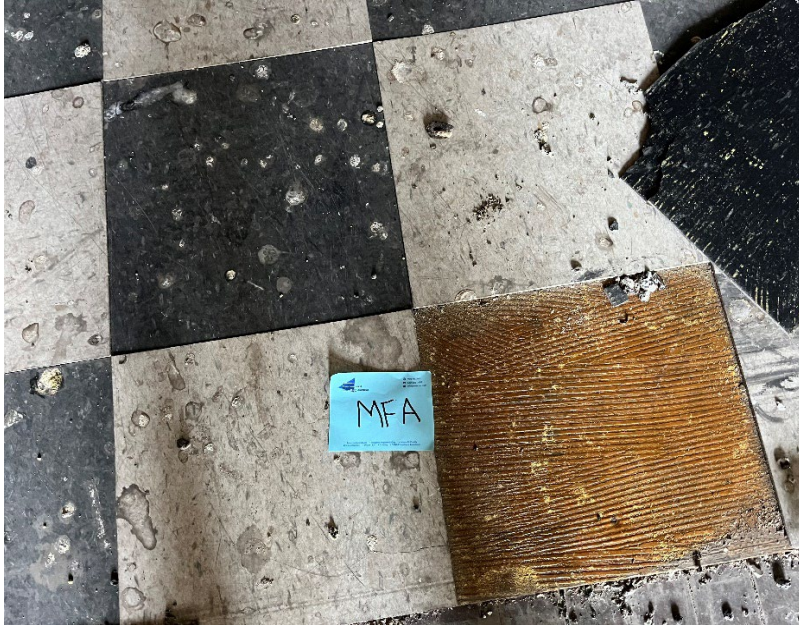
| Homogeneous Area: | MFA |

| H S A | MATERIAL DESCRIPTION | MATERIAL LOCATION | ACM CATEGORY | TYPE OF ANALYSIS OR ASSUMED | MATERIAL CONDITION | MATERIAL TYPE | APPROX. QUANTITY | ACM YES/NO | COMMENTS |
|---|---|---|---|---|---|---|---|---|---|
| MFA | Black & White 12"x12" Floor Tile/Mastic | 2nd floor - North center hallway, SW Stair Landings, 2nd floor office | Cat I Non-friable | PLM | D | Misc | 330 sf | No | N/A |

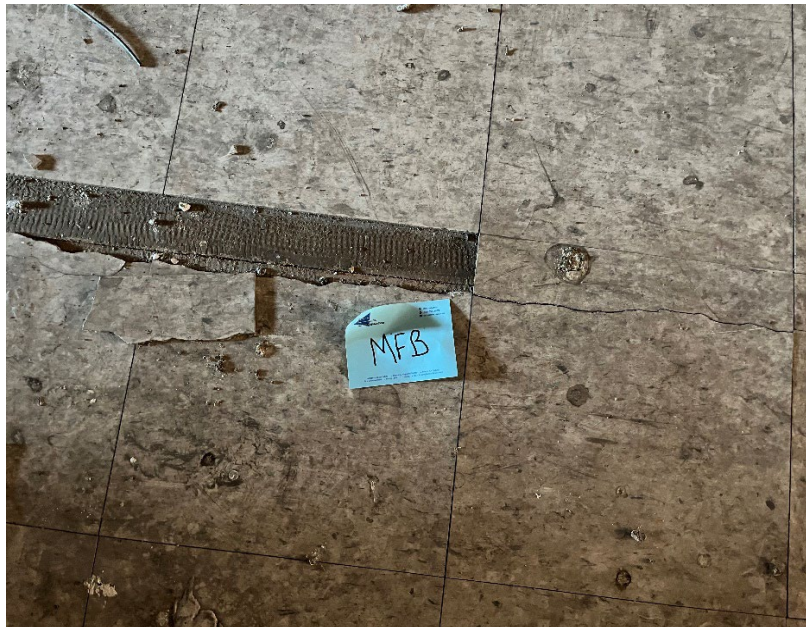
| Homogeneous Area: | MFB |

| H S A | MATERIAL DESCRIPTION | MATERIAL LOCATION | ACM CATEGORY | TYPE OF ANALYSIS OR ASSUMED | MATERIAL CONDITION | MATERIAL TYPE | APPROX. QUANTITY | ACM YES/NO | COMMENTS |
|---|---|---|---|---|---|---|---|---|---|
| MFB | White 12"x12" Floor Tile/Mastic | 2nd floor kitchen | Cat I Non-friable | PLM | D | Misc | 300 sf | No | N/A |

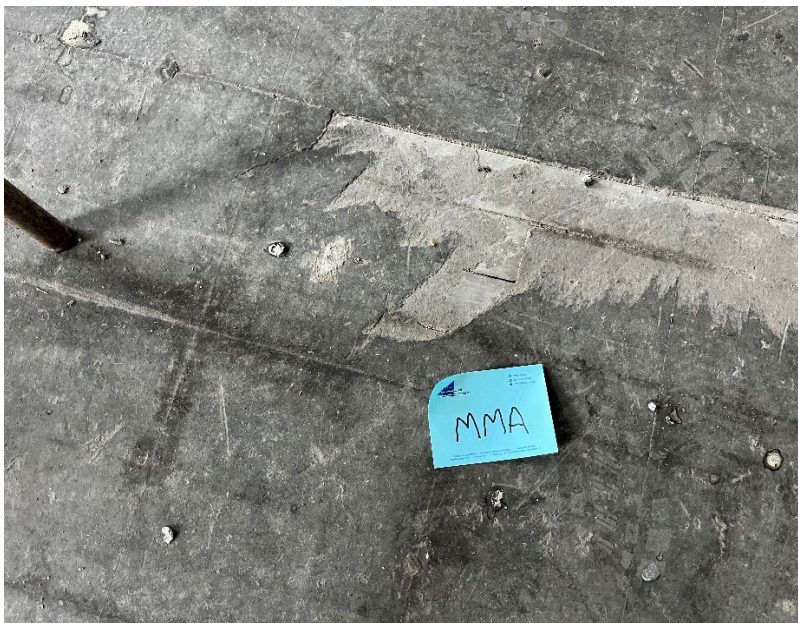
| Homogeneous Area: | MMA |

| H S A | MATERIAL DESCRIPTION | MATERIAL LOCATION | ACM CATEGORY | TYPE OF ANALYSIS OR ASSUMED | MATERIAL CONDITION | MATERIAL TYPE | APPROX. QUANTITY | ACM YES/NO | COMMENTS |
|---|---|---|---|---|---|---|---|---|---|
| MMA | Residual Mastic | 2nd floor - Large Office Space | Cat I Non-friable | PLM | D | Misc | 800 sf | No | N/A |

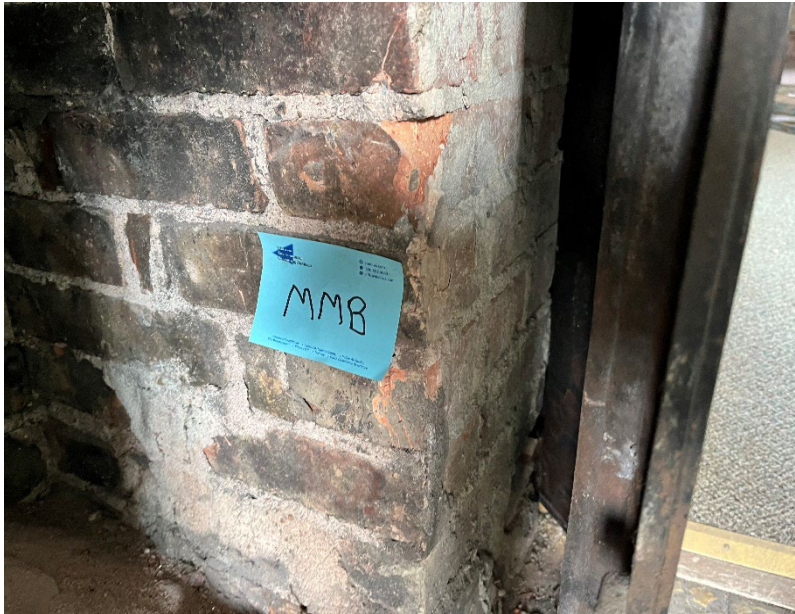
| Homogeneous Area: | MMB |

| H S A | MATERIAL DESCRIPTION | MATERIAL LOCATION | ACM CATEGORY | TYPE OF ANALYSIS OR ASSUMED | MATERIAL CONDITION | MATERIAL TYPE | APPROX. QUANTITY | ACM YES/NO | COMMENTS |
|---|---|---|---|---|---|---|---|---|---|
| MMB | Fireplace Brick | 2nd floor - west wall fireplace | Cat II Non-friable | PLM | ND | Misc | 20 sf | No | N/A |

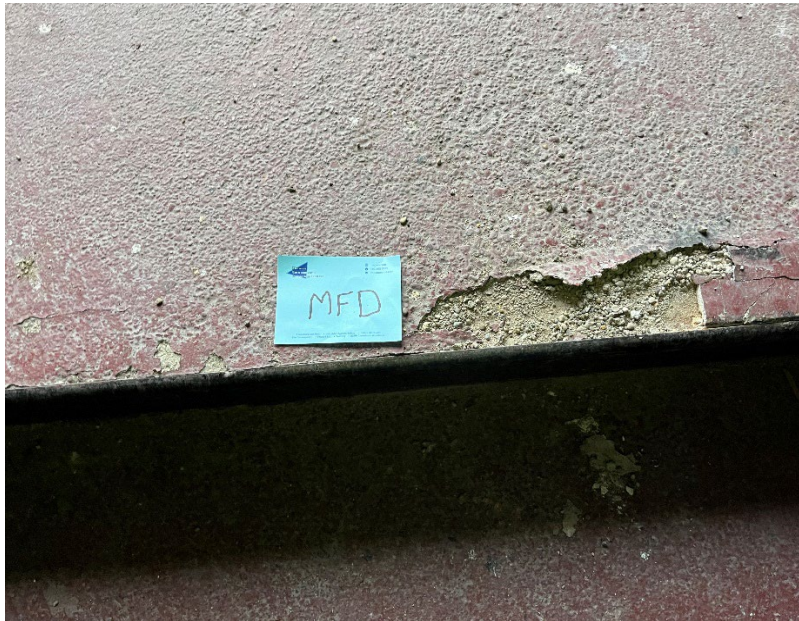
| Homogeneous Area: | MFD |

| H S A | MATERIAL DESCRIPTION | MATERIAL LOCATION | ACM CATEGORY | TYPE OF ANALYSIS OR ASSUMED | MATERIAL CONDITION | MATERIAL TYPE | APPROX. QUANTITY | ACM YES/NO | COMMENTS |
|---|---|---|---|---|---|---|---|---|---|
| MFD | Expoxy Floor - Red | Northwest Stairs | Cat I Non-Friable | PLM | ND | Misc | 320 sf | No | N/A |

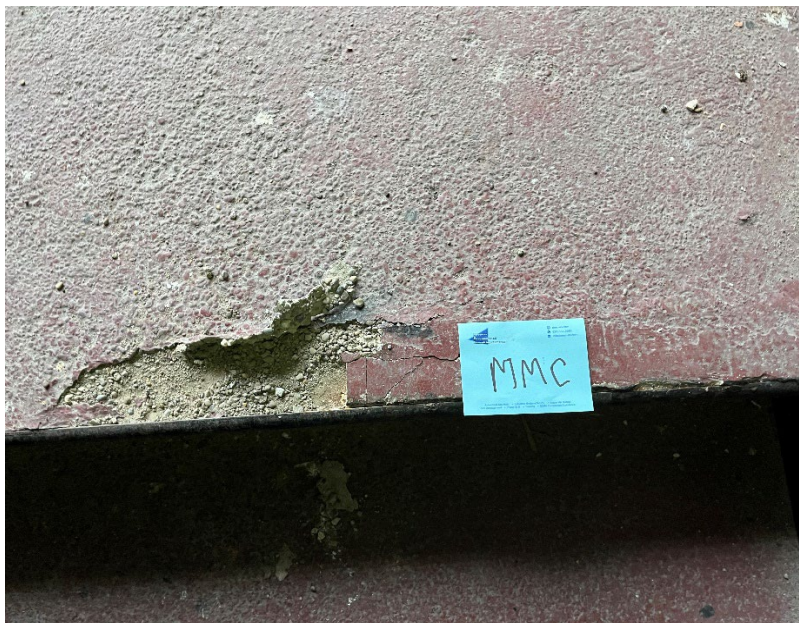
| Homogeneous Area: | MMC |

| H S A | MATERIAL DESCRIPTION | MATERIAL LOCATION | ACM CATEGORY | TYPE OF ANALYSIS OR ASSUMED | MATERIAL CONDITION | MATERIAL TYPE | APPROX. QUANTITY | ACM YES/NO | COMMENTS |
|---|---|---|---|---|---|---|---|---|---|
| MMC | Floor Fill | Northwest Stairs at landing/stair interfaces | Cat II Non-friable | PLM | D | Misc | 30 sf | No | N/A |

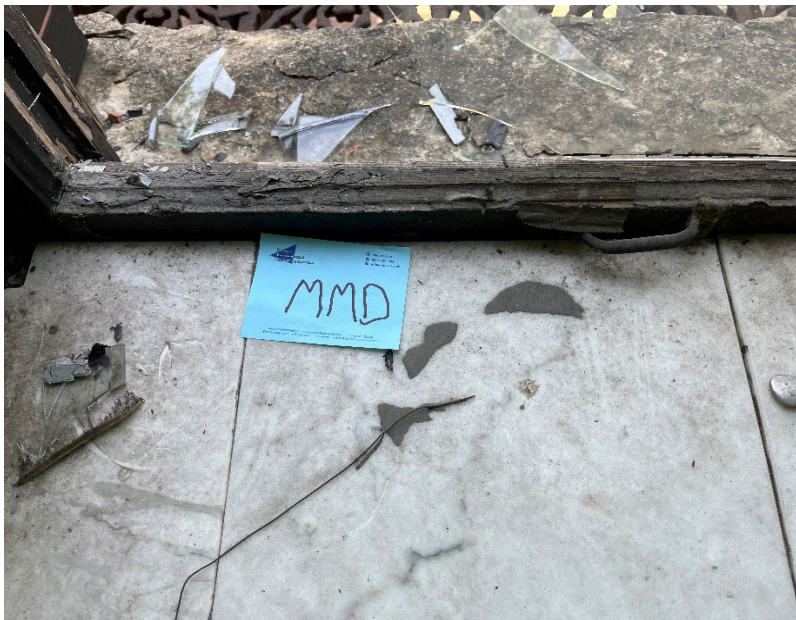
| Homogeneous Area: | MMD |

| H S A | MATERIAL DESCRIPTION | MATERIAL LOCATION | ACM CATEGORY | TYPE OF ANALYSIS OR ASSUMED | MATERIAL CONDITION | MATERIAL TYPE | APPROX. QUANTITY | ACM YES/NO | COMMENTS |
|---|---|---|---|---|---|---|---|---|---|
| MMD | Window Glazing Compound - Wood Windows | Exterior Wood Windows | Cat II Non-friable | PLM | D | Misc | 24 windows | No | N/A |

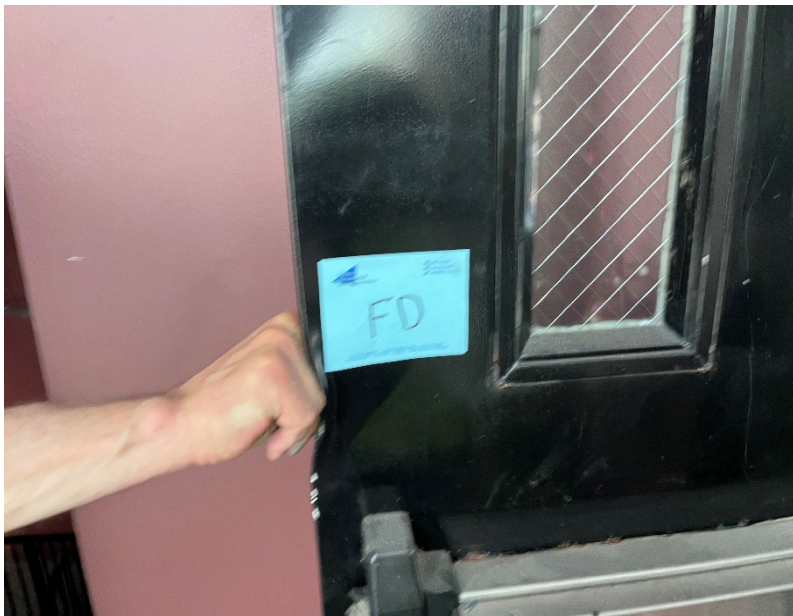
| Homogeneous Area: | FD |

| H S A | MATERIAL DESCRIPTION | MATERIAL LOCATION | ACM CATEGORY | TYPE OF ANALYSIS OR ASSUMED | MATERIAL CONDITION | MATERIAL TYPE | APPROX. QUANTITY | ACM YES/NO | COMMENTS |
|---|---|---|---|---|---|---|---|---|---|
| FD | Fire Door Insulation | Metal Fire Doors - Throughout | Cat II Non-friable | PLM | ND | Misc | 8 doors | No | N/A |

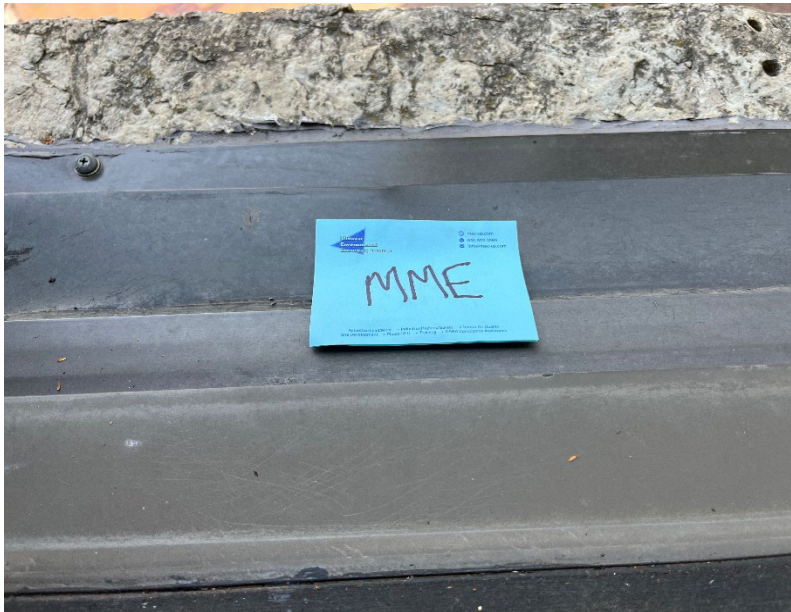
| <b>Homogeneous Area:</b> | <b>MME</b> |

| H S A | MATERIAL DESCRIPTION | MATERIAL LOCATION | ACM CATEGORY | TYPE OF ANALYSIS OR ASSUMED | MATERIAL CONDITION | MATERIAL TYPE | APPROX. QUANTITY | ACM YES/NO | COMMENTS |
|---|---|---|---|---|---|---|---|---|---|
| MME | Window Caulk - Wood Windows | Exterior Wood Windows | Cat II Non-friable | PLM | D | Misc | 24 windows | No | N/A |

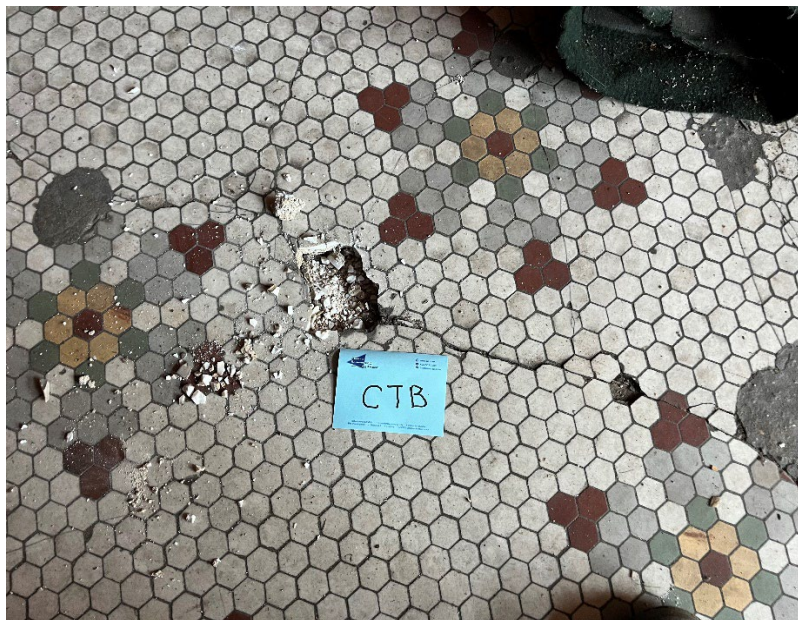
| <b>Homogeneous Area:</b> | <b>CTB</b> |

| H S A | MATERIAL DESCRIPTION | MATERIAL LOCATION | ACM CATEGORY | TYPE OF ANALYSIS OR ASSUMED | MATERIAL CONDITION | MATERIAL TYPE | APPROX. QUANTITY | ACM YES/NO | COMMENTS |
|---|---|---|---|---|---|---|---|---|---|
| CTB | Hexagonal Ceramic Tile | 1st floor - former tavern and northwest stair | Cat II Non-friable | PLM | D | Misc | 2,050 sf | No | N/A |

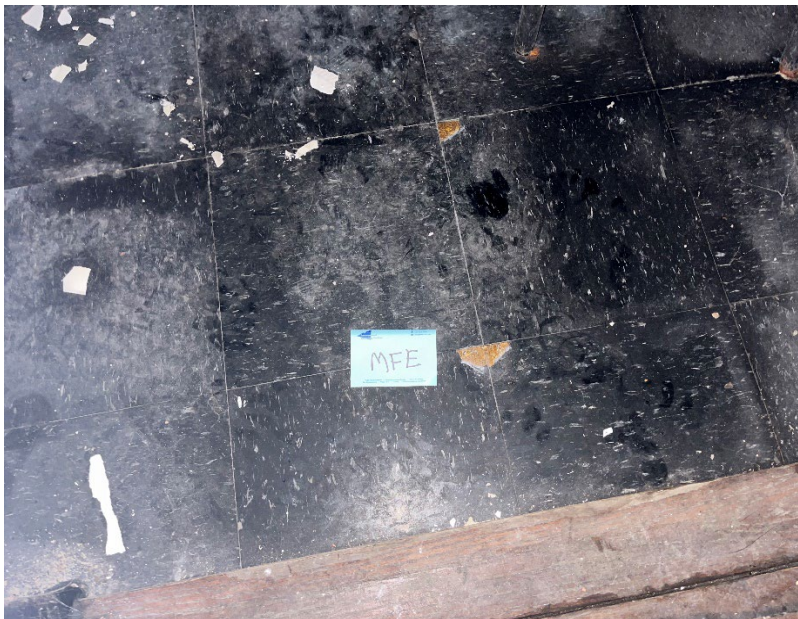
| <b>Homogeneous Area:</b> | <b>MFE</b> |

| H S A | MATERIAL DESCRIPTION | MATERIAL LOCATION | ACM CATEGORY | TYPE OF ANALYSIS OR ASSUMED | MATERIAL CONDITION | MATERIAL TYPE | APPROX. QUANTITY | ACM YES/NO | COMMENTS |
|---|---|---|---|---|---|---|---|---|---|
| MFE | Black 12"x12" Floor Tile/Mastic | 1st floor - Men's Restroom | Cat I Non-friable | PLM | D | Misc | 140 sf | No | N/A |

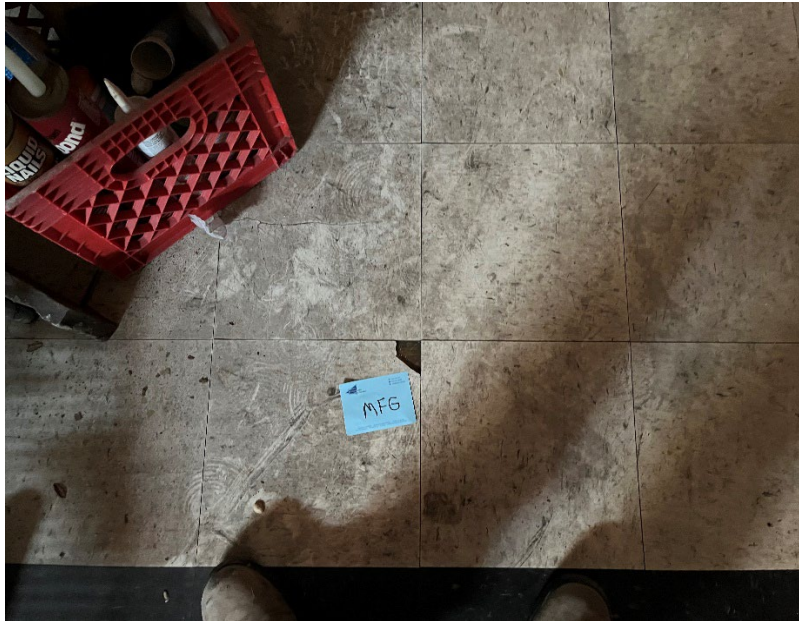
| Homogeneous Area: | MFG |

| H S A | MATERIAL DESCRIPTION | MATERIAL LOCATION | ACM CATEGORY | TYPE OF ANALYSIS OR ASSUMED | MATERIAL CONDITION | MATERIAL TYPE | APPROX. QUANTITY | ACM YES/NO | COMMENTS |
|---|---|---|---|---|---|---|---|---|---|
| MFG | White 12"x12" Floor Tile/Mastic - 1st floor | 1st floor - Kitchen | Cat I Non-friable | PLM | D | Misc | 700 sf | No | N/A |
